Factsheet updated 15 April 2014

Roof Motor Service

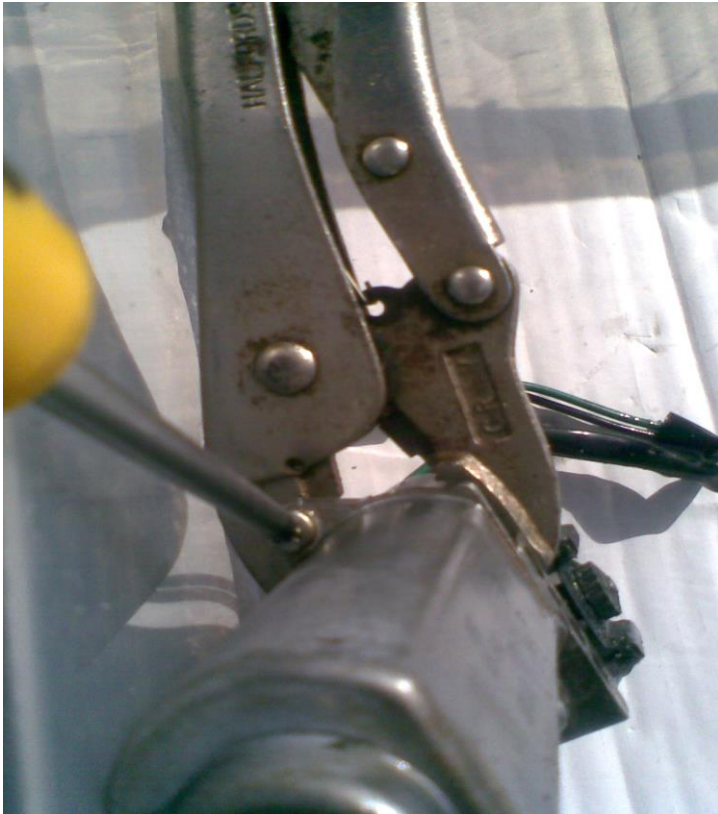
Once I had the motor removed I took the clear plastic underbed storage box. Holding the motor in the box I carefully removed the 2 cross head screws that hold the 2 sections of the casing together. This has to be done slowly and carefully as there are springs and ball bearings that can be easily be lost.

It may be necessary to soak the screws with WD40 first and use a vice or holding frame to get purchase on the screws when removing. I needed to grip the screw with a small set of mole grips on one of the motors to get the initial turn. Once the screws have loosened the motor can be taken out of the holding device and the screws can be fully removed back in the underbed box.

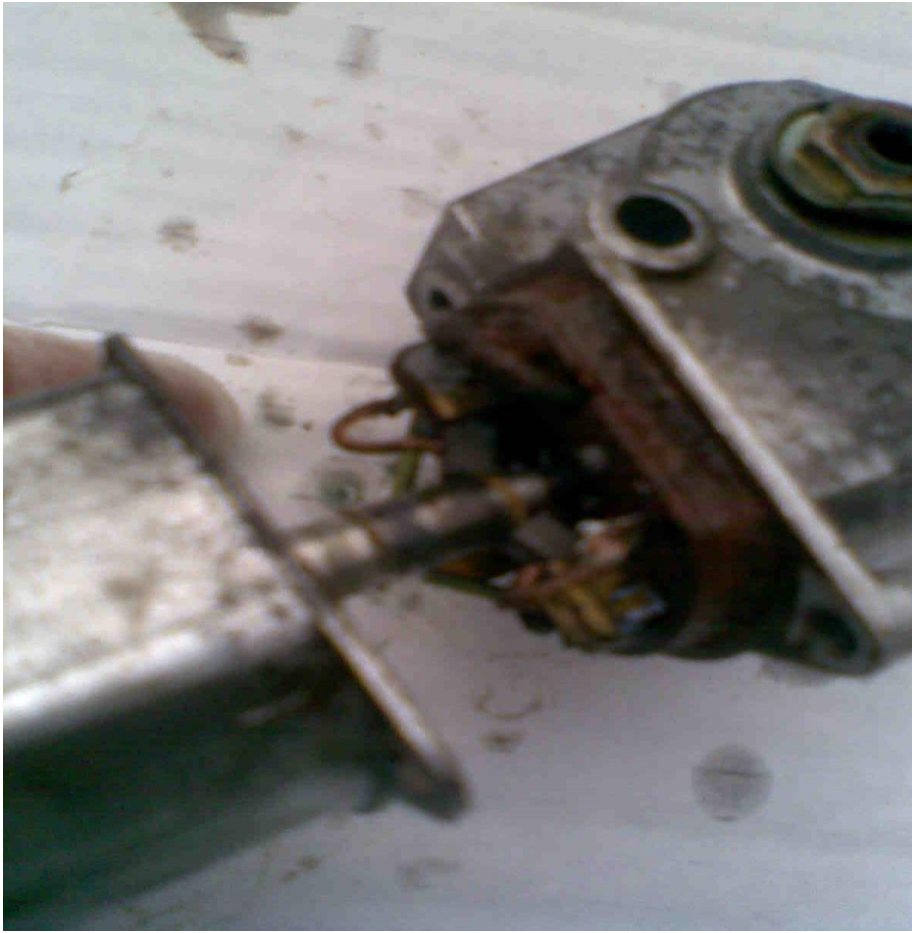
Slowly ease the 2 halves of the motor casing apart. The long end maybe easiest to pull away first, they'll will be some resistance due to the powerful magnets in the casing. When the long end of the casing is removed the ball bearings if lucky should still be attached to each end of the spindle on the rotor. The bearing may fall into the box or it could be stuck on the magnets inside the long casing. Use a torch if necessary to locate the bearing and remove it with a suitable implement. It may take a few attempts. Clean the bearing and store safely. Placing it on sticky tape is handy.

The plates on the exposed end of the rotor can now be seen. Mine had rust and dirt on them and the long casing was rusty and generally gunged up inside. After servicing three motors this seems to be the main weak point, the join between the two sections of casing. I will cover this later. Now slowly remove the other end of the rotor from the other side of the casing.

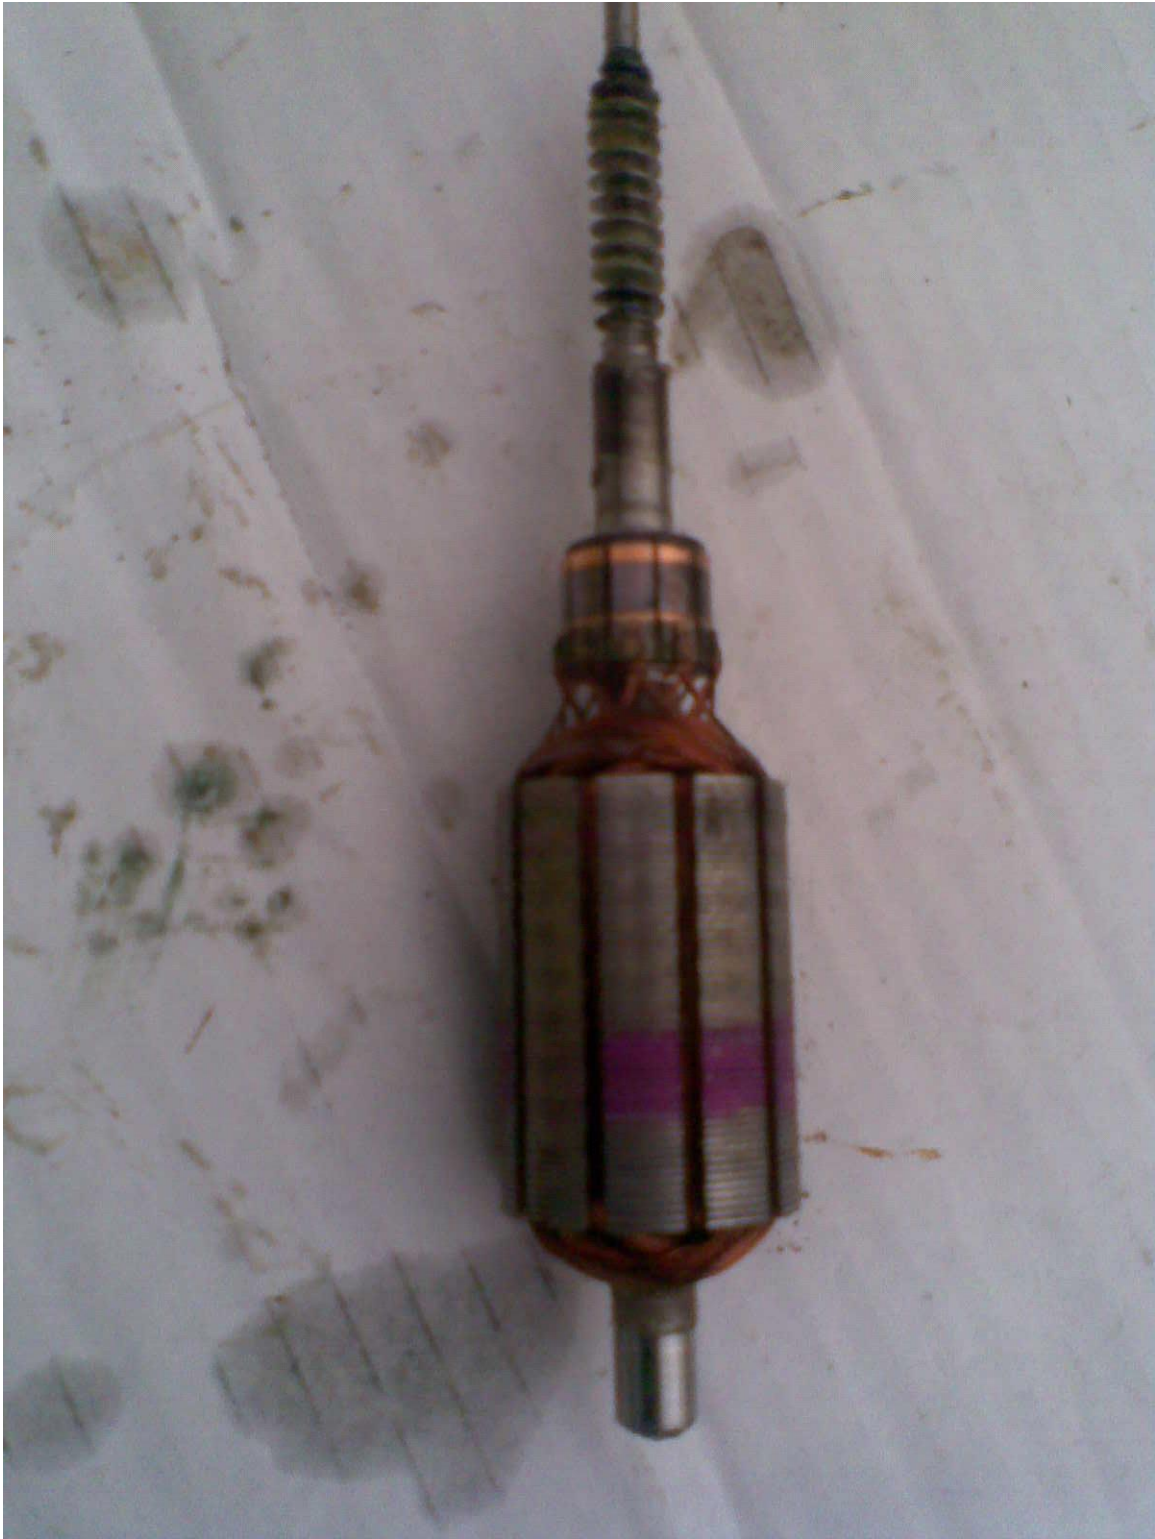
Photo Above - Rotor Before Cleaning

There is a threaded spindle on the end so it may need to be twisted around a bit etc. On the end of the threaded spindle is a very small ball bearing. Remove the bearing, clean it and stick onto some tape. The picture below shows the rotor removed. The plates have had an quick clean before the photo, they may be in a much worst state than this. On each end of the rotor is the recess where the ball bearings are located. The bearing on the threaded end is very small.

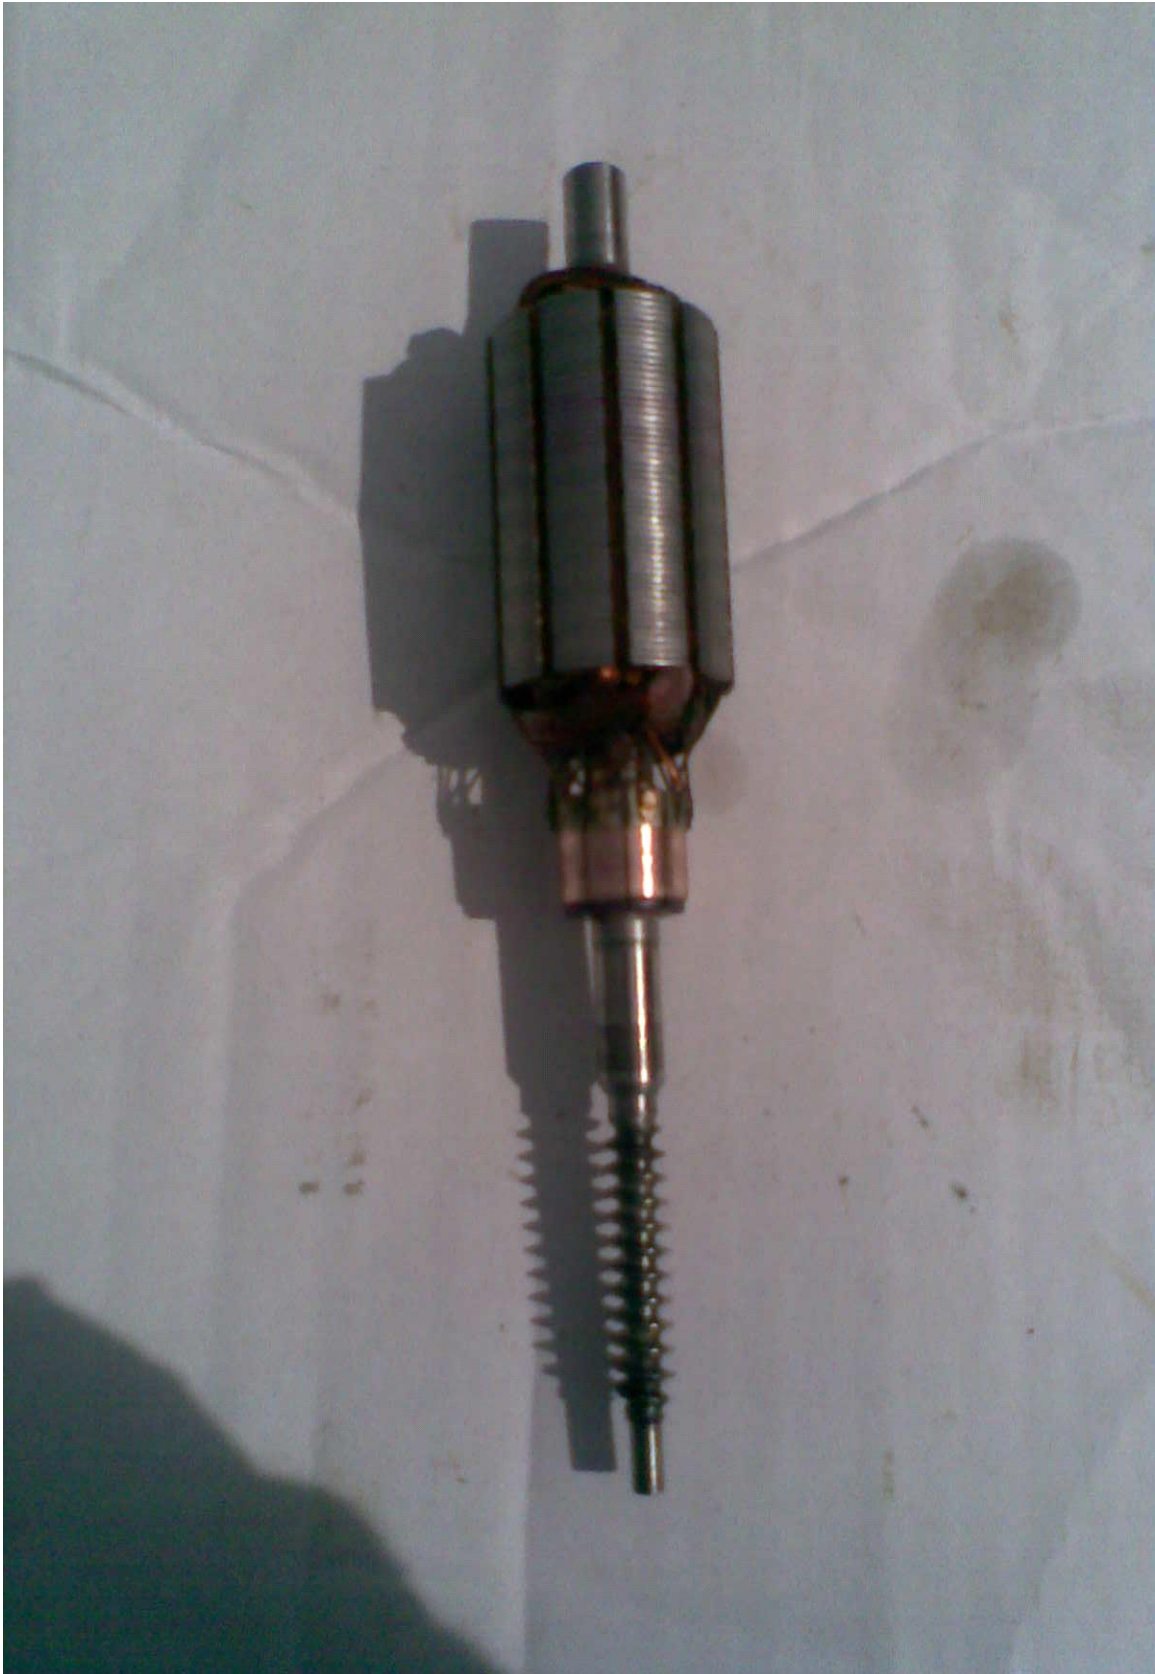
Photo Below - Rotor After Cleaning

I used a very fine wet/dry paper to rub down the rusty plates on the rotor arm. Make sure the rotor is free from any dust after you've finished. They came up quite nicely. Also the area where the brushes make contact on the rotor arm. (copper coloured band at the midway point that wraps around the rotor)

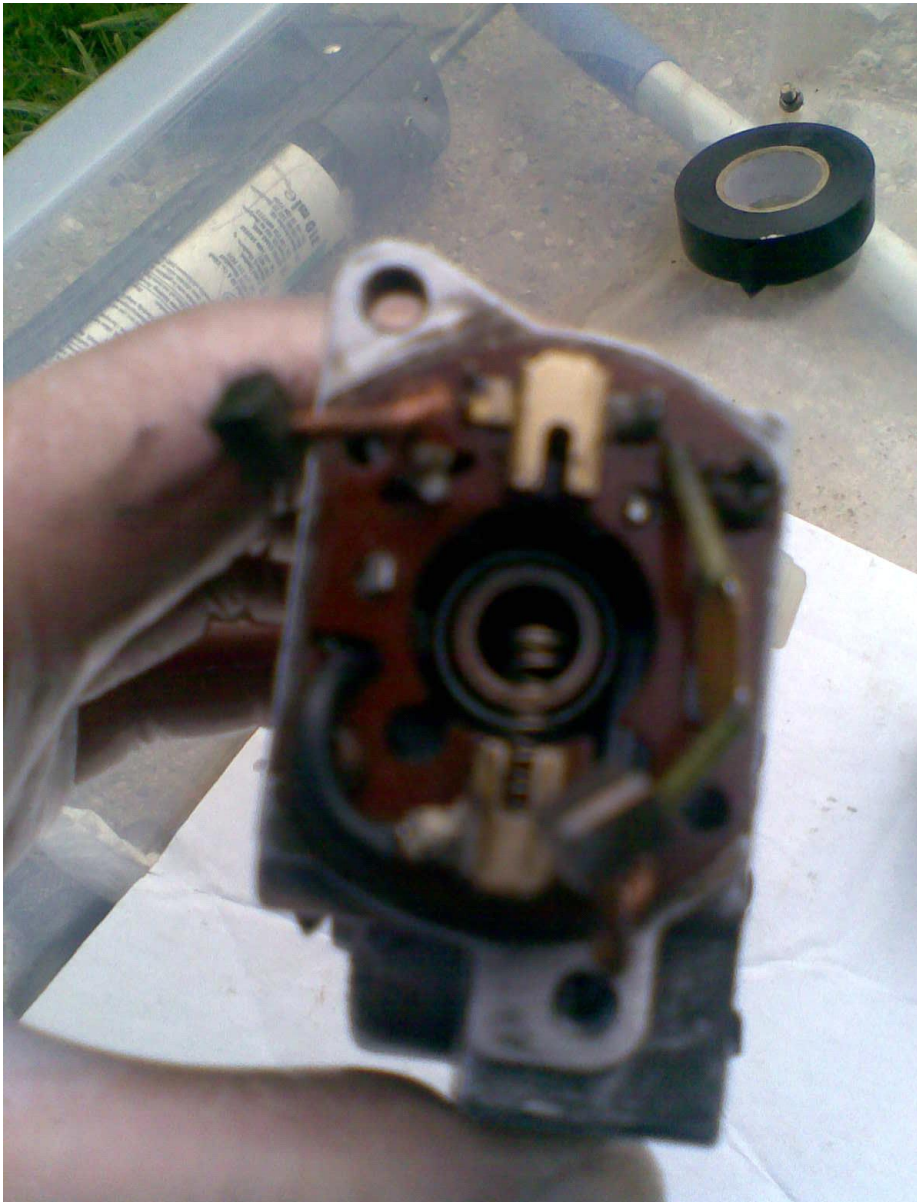
You will see 2 springs on the cog side of the casing which hold the brushes against the rotor. Note the position/angle of the brushes before you remove the rotor if you can. The brushes are slightly concave where they're held against the body of the rotor. This is the way they need to go back in. The wiring that connects them goes through the little slot at the top of the housing where the brushes are located. It's possible to put these back in 180 degrees out, so make a note of positions at this point. The picture shows the housings for the springs and brushes. You can just see one of the brushes by my finger and a spring sitting in one of the housings.

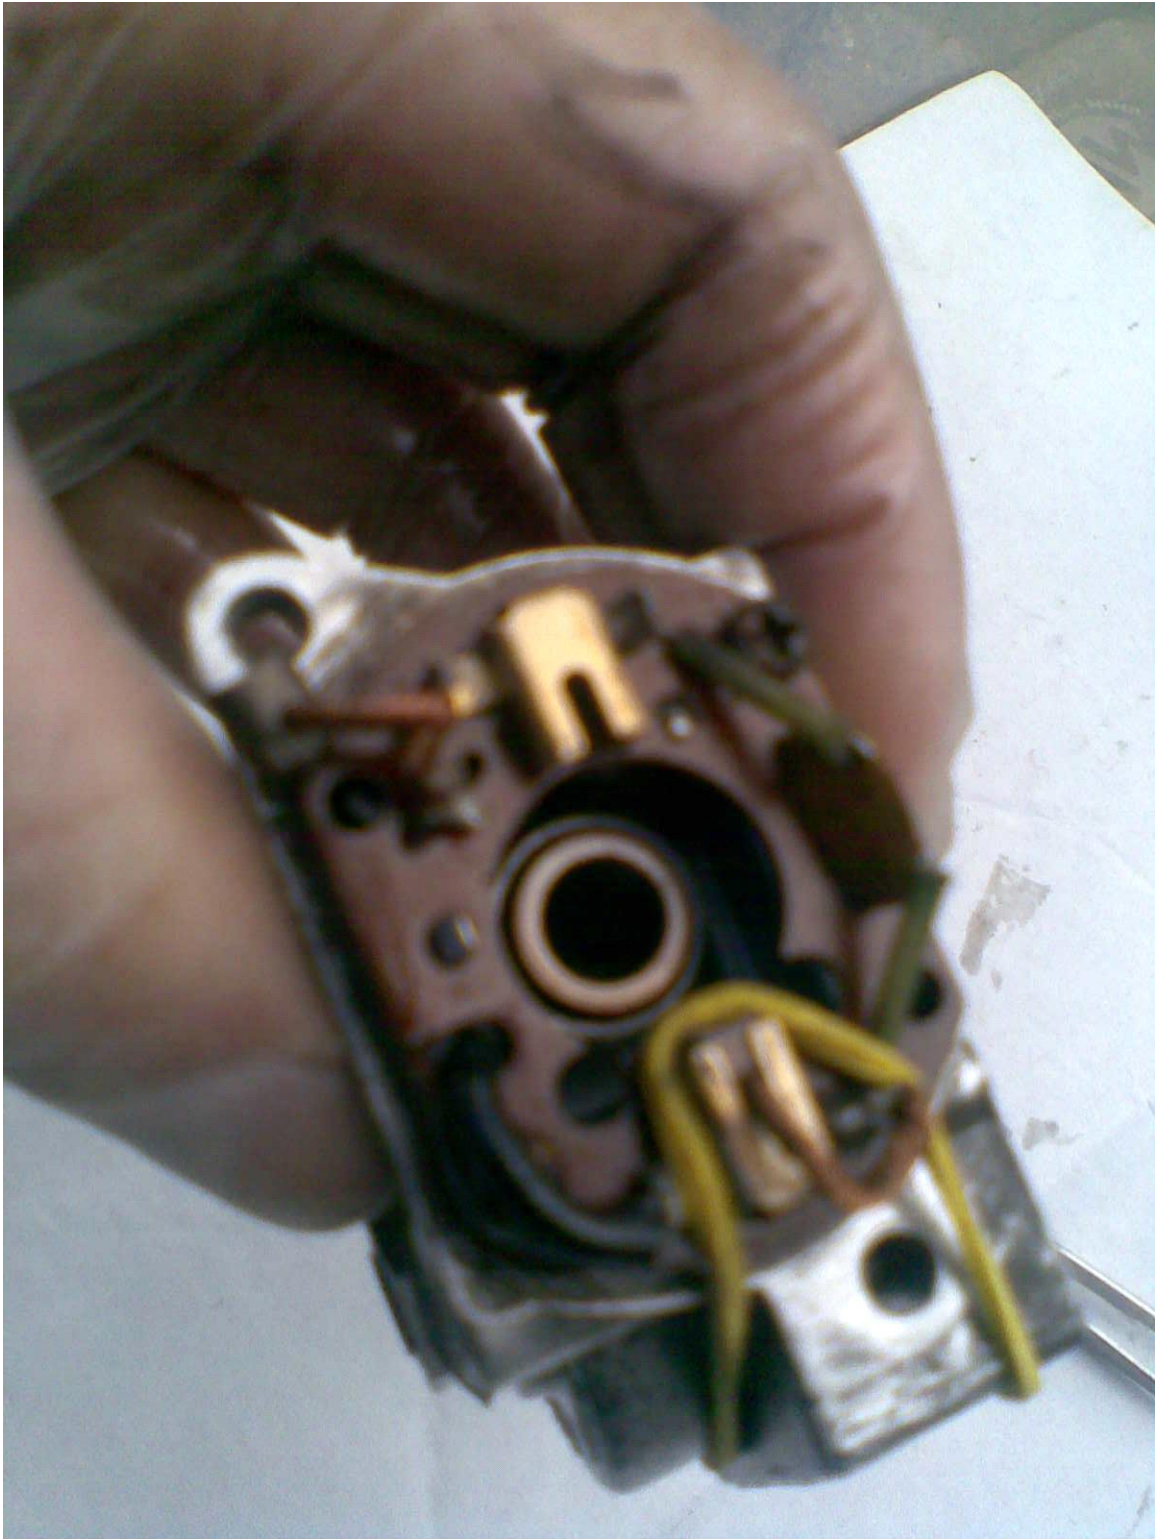
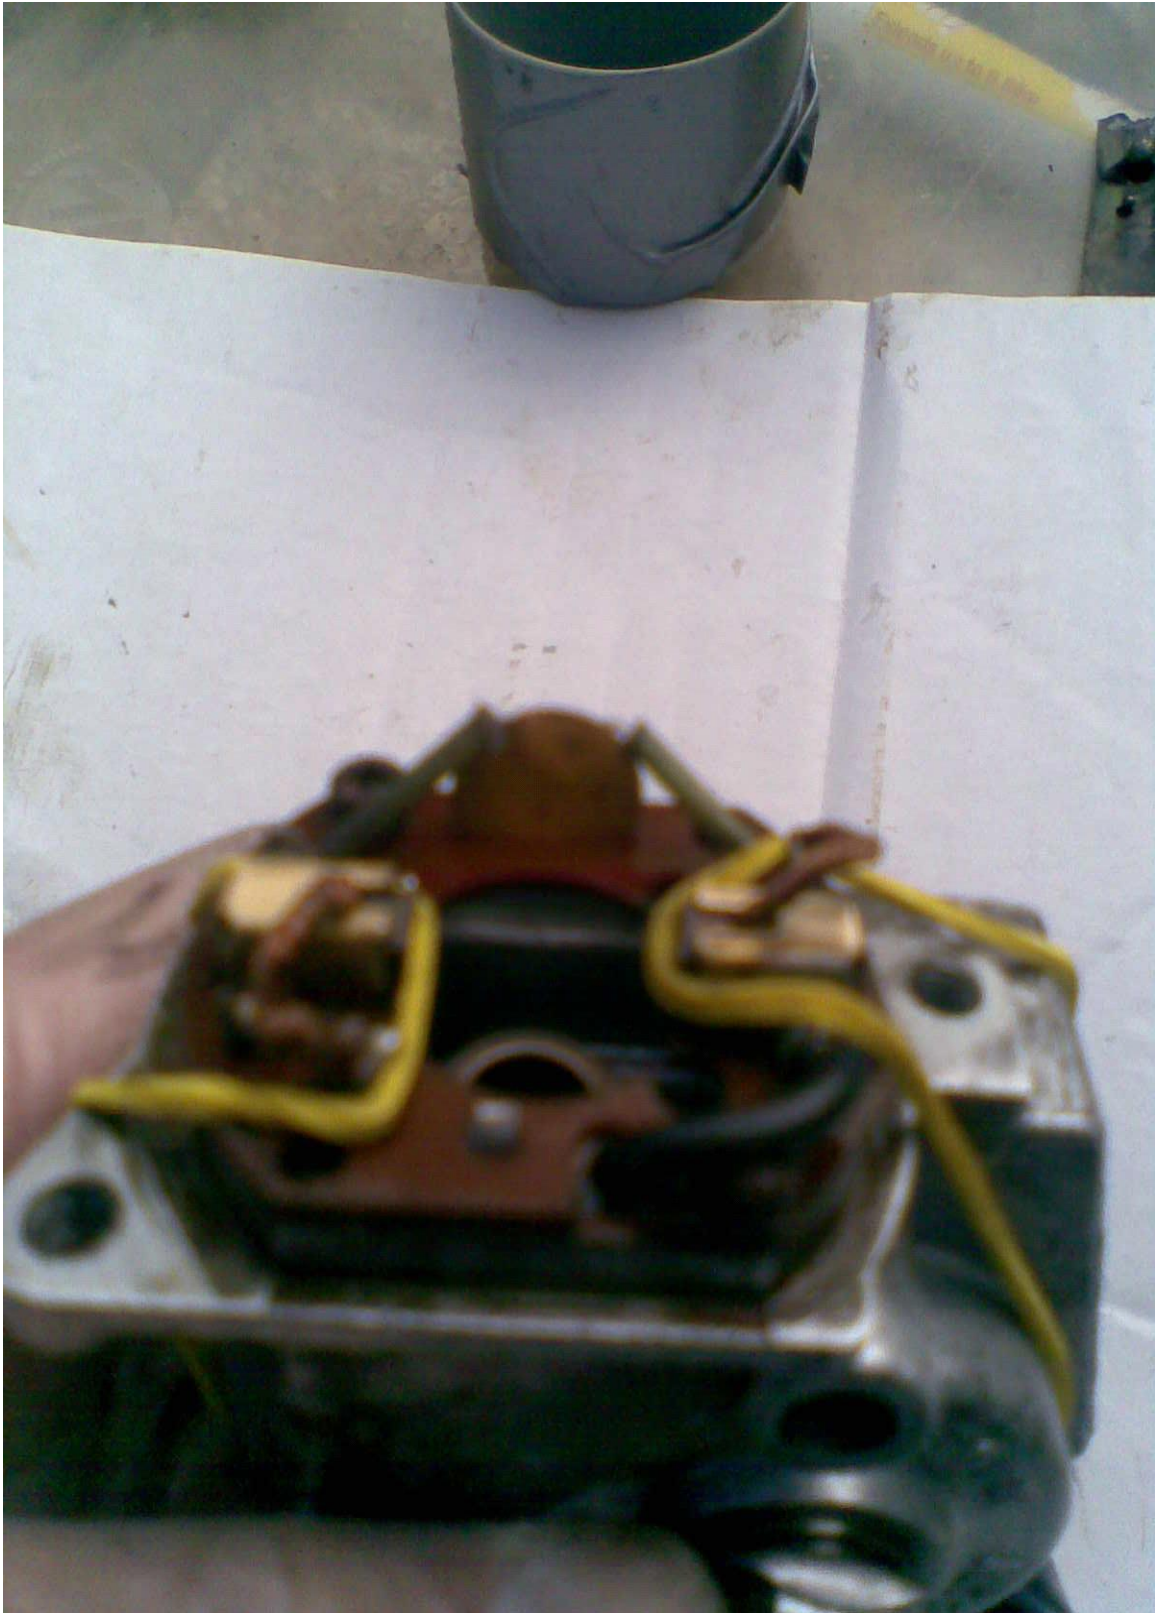
When the brush and spring are in position use the elastic band to hold the brush in position by stretching it across the face of the brush and then wrapping it around the bottom body of the casing. It's important that the rubber band is not too thick, thinner the better without breaking too easy. The first brush will now stay in position and you can repeat the process for the other side. Picture below shows the first spring and brush being held in position by the elastic band.

Now comes the tricky bit, reassembly. This little brainwave probably saved me many hours trying to get the springs and brushes located correctly. It's mind bogglingly fiddly without this method. Get two thin elastic bands and a pair of tweezers. Place the first spring back in its housing and hold in with a finger or a small lolly stick etc, if your fingers are like sausages. Use fingers if you're nimble or tweezers to locate the brush back into the housing. Hold the spring in position. Then push the spring in as far as possible with the brush. Make sure the brush has the wiring located at the slot in the top of the housing with the curved face located correctly, facing the rotor.

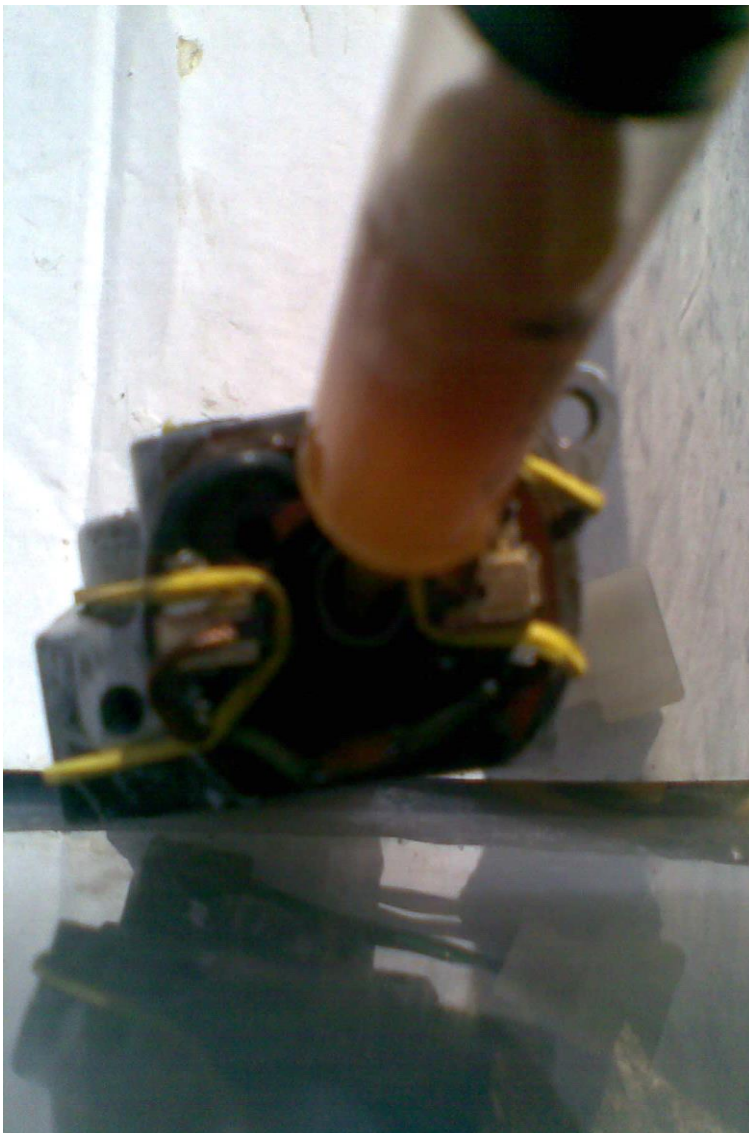
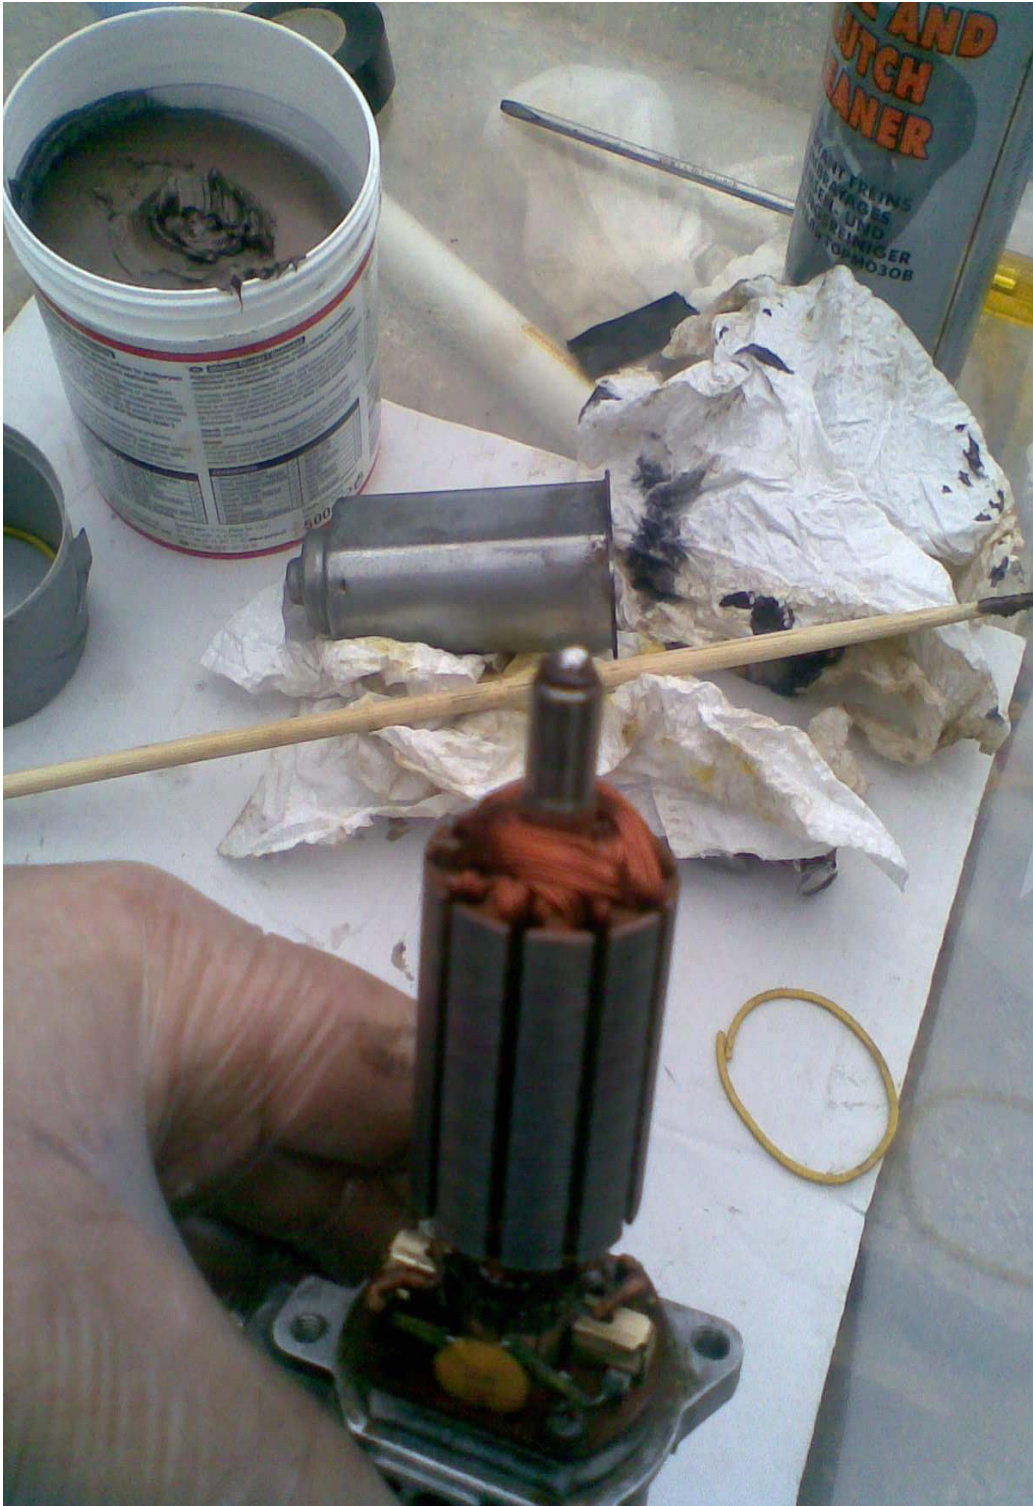
Pictures Below show show grease being injected with the plastic syringe into the cog end of the casing and the rotor in position after being lowered back into the casing and the elastic bands removed.

Now after greasing the spindle, and ensuring the small ball bearing is seated on the end with copper grease, carefully lower it into the casing. It will need to be wiggled and twisted carefully to get it to sit down fully. On one of the motors I did, it took a while to seat the rotor correctly. At this point the contacts on the rotor will press against the rubber bands (this is why they need to be thin). The bands can now be cut one at a time close to the rotor. Then with a half turn or so of the rotor, the rubber band will come out completely and can be pulled clear. Repeat for other side.

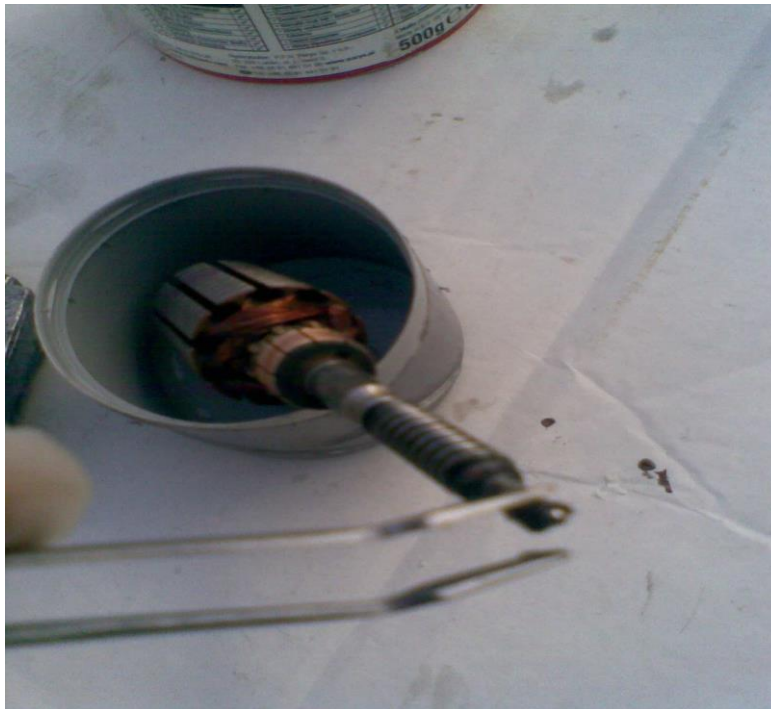
The next bit I found tricky as well. The ball bearings needs to be located in the recess on the ends of the spindles on the rotor arm. However the magnets will pull it straight out when putting on the long casing side (large ball bearing end). I got round this by putting a dab of copper grease on the end and then putting the casing on. It took a couple of attempts, but less than 5 minutes. Without something to keep the ball bearing in position it's near on impossible. You can see the large ball bearing in position in the previous picture and the small bearing at the threaded end below.

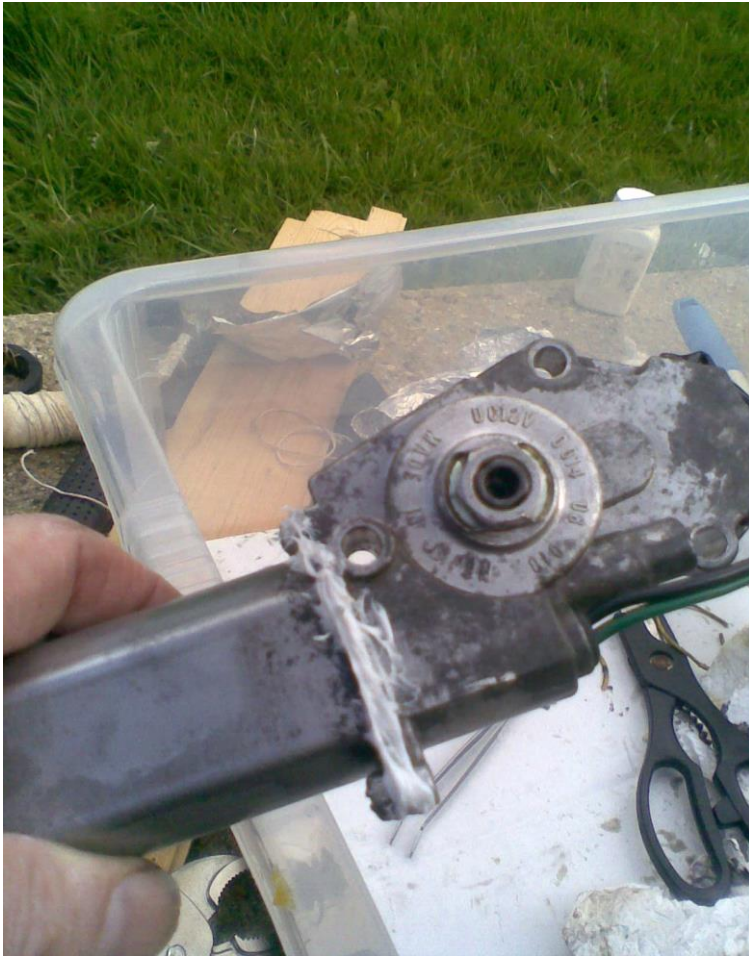
I closed the 2 casings together. If you find there's a gap, then the end which drives the cog is probably not seated properly and will need to be twisted around a bit until you feel it sit down fully. This could be easy or may take some time, two motors were easy one took much longer to do. Replace the screws and tighten fully. At this point I tested the motor on 12v and it worked a treat. Then I put some sealant around the join in the 2 casings to help prevent future ingress of moisture as this seems to be the main weak spot. I made a bit of a mess with the sealant but the picture below will give you an idea. Not pretty but hopefully effective. Not a job you want to have to repeat in a few years time.
